Technical Memorandum BCWA

Date: February 8, 2017
To: Bear Creek Watershed Association
From: Russell N. Clayshulte, Manager
Re: BCWA TM 2016.02 UBCW Summary

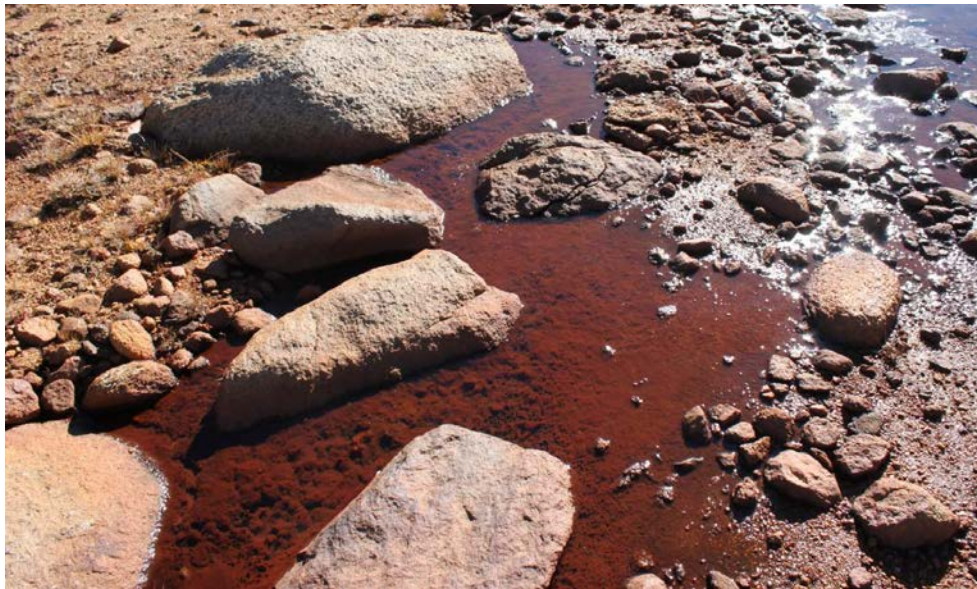
Figure 3 Excessive red algal growth typical in fen ponds along the suspected pollutant plume flow

The preliminary data analyses from just visually tracing high algal productivity in the fen ponds showed extremely elevated nutrients, that were higher than found anywhere else in the watershed (Figure 3). In 2013, measurements from only a single estimated emergent point of the plume had a seasonal average total phosphorus of 1,801 ug/l (maximum 4,112 ug/l), with a conservative estimate of 129 pounds/month discharged into upper Bear Creek (potentially over 400 pounds in the warm season). That is potentially more total phosphorus discharged into Bear Creek than 10 out of 16 wastewater treatment plants discharge in an entire year. Denver Parks and Recreation in 2013 repaired the new vaults and the 2014 water quality data suggests this helped resolve part of the nutrient loading.

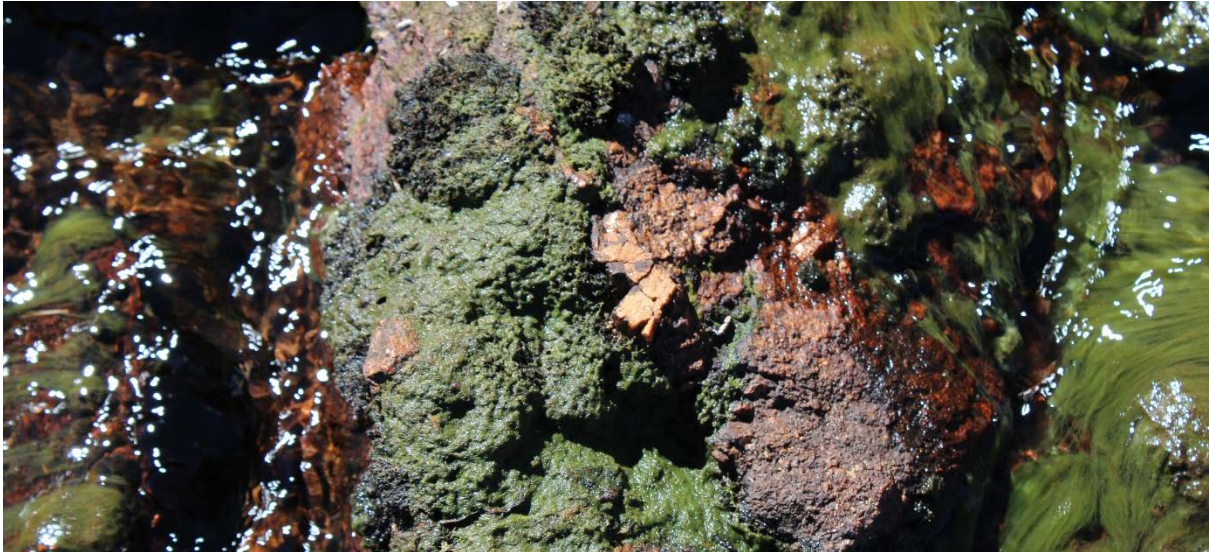
Figure 7 Algal growth in Bear Creek upstream of site 37

Although the fen plume monitoring site continues to produce an elevated phosphorus loading, this load is not reflected in the concentrations and load measured at site 37. This indicates that algal productivity is consuming much of the nutrient load prior to this monitoring site (Figure 10). Most of the recent algal grow appears to be several species of green algae. There does continue to be a potential problematic bluegreen algae that may be associated with the observed fish kills. Almost all of this algal mat material will die over the winter and flush downstream in the spring runoff. As such, the nutrient load gets flushed downstream as organic matter.
